IMPROVEMENT OF SCREENING METHODS FOR SILICON PLANAR DEVICES

QUARTERLY PROGRESS REPORT

1 APRIL 1970 - 30 JUNE 1970

PHILCO-FORD CORPORATION MICROELECTRONICS DIVISION

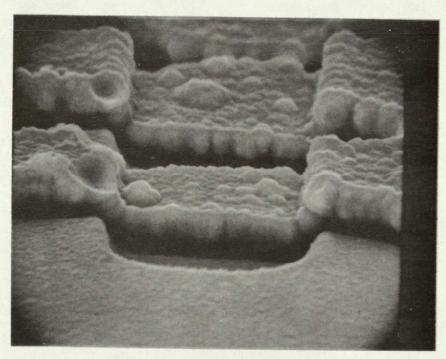
Figure 3 illustrates the typical billowing of the deposited dielectric at the edges of oxide steps and small mounds and depressions in the deposited dielectric. The mounds and depressions are of little significance because the deposited dielectric provides mechanical protection of the metallization and thermal oxide surfaces of the device. Figure 4 shows the same area as Figure 3 after removal of the deposited dielectric, presumably by buffered HF. It should be noted that the deposited dielectric etch also removed a thin layer of the thermal oxide, estimated to be approximately 2000 & thick from the thickness of the metal stripe, and may have also resulted in the removal of a lesser thickness of the aluminum metallization. The removal of the thermal oxide is exhibited by the thin layer of glass visible between the bottom of the metal stripes and the planar surface of the thermal oxide. The photomicrograph shows, however, more than adequate metal coverage at the oxide step, considering the low current carrying requirements of this MOS device, and a good taper of the oxide step, which minimizes shadowing during aluminum evaporation and results in reliable metallization coverage at steps.

FIGURE 3 - SEM PHOTOMICROGRAPH, PRIOR TO DEPOSITED DIELECTRIC REMOVAL, OF AREA INDICATED BY ARROW IN FIGURE 1.

BILLOWING OF DEPOSITED DIELECTRIC IS VISIBLE ON TOP OF METAL WHERE METAL STEPS INTO OXIDE CUTS. MOUNDS & DEPRESSIONS IN THE DEPOSITED DIELECTRIC ARE ALSO VISIBLE. (MAG. = 5700X, ANGLE = 65°)

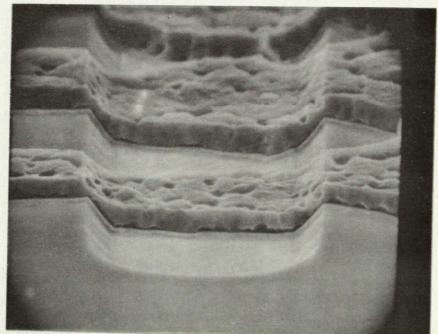
FIGURE 4 - SEM PHOTOMICROGRAPH, SUBSEQUENT TO DEPOSITED OXIDE REMOVAL, OF SAME AREA SHOWN IN FIGURE 3. GOOD METALLIZATION COVERAGE AT TAPERED OXIDE STEP IS VISIBLE. THIN LAYER VISIBLE UNDER METAL STRIPES INDICATES SOME THERMAL OXIDE REMOVAL DURING DEPOSITED OXIDE ETCH.

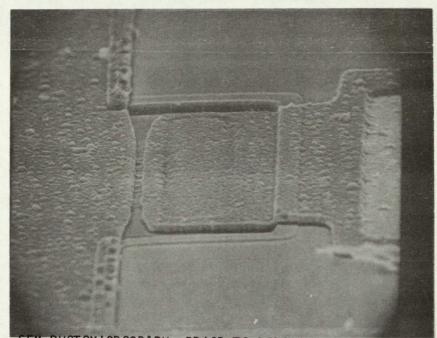
FIGURE 7 - SEM PHOTOMICROGRAPH, PRIOR TO DEPOSITED OXIDE REMOVAL, OF AREA INDICATED BY ARROW 2 OF FIGURE 5. PHOTOMICRO-GRAPH SHOWS BRIDGING OF METALLIZATION PATTERN.

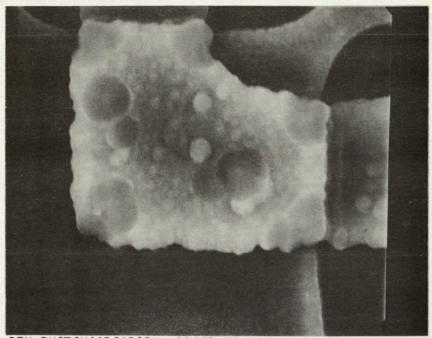
FIGURE 9 - SEM PHOTOMICROGRAPH, PRIOR TO DEPOSITED OXIDE REMOVAL,
OF AREA INDICATED BY ARROW 3 OF FIGURE 5. DARK AND LIGHT
CIRCLES IN AREA OVER METAL STRIPE ARE THE RESULT OF MOUNDS
AND DEPRESSIONS IN THE DEPOSITED OXIDE AND DO NOT AFFECT
RELIABILITY OF DEVICE.

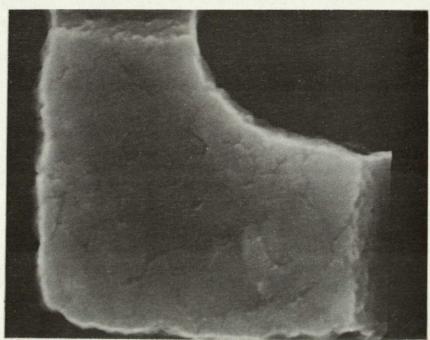
FIGURE 10 - SEM PHOTOMICROGRAPH, SUBSEQUENT TO DEPOSITED OXIDE REMOVAL, OF SAME AREA SHOWN IN FIGURE 9. NOTE RELATIVELY SMOOTH METALLIZATION SURFACE COMPARED TO CIRCULAR AREAS VISIBLE IN FIGURE 9.

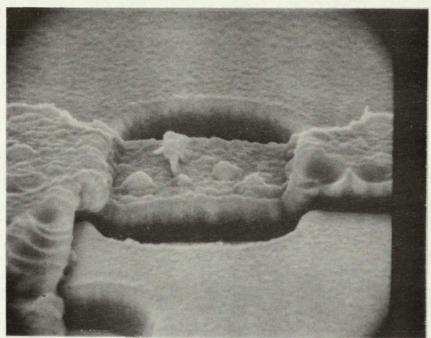
FIGURE 11 - SEM PHOTOMICROGRAPH, PRIOR TO DEPOSITED OXIDE REMOVAL, OF AREA INDICATED BY ARROW 3 OF FIGURE 5. MOUNDS AND DEPRESSIONS IN THE DEPOSITED OXIDE ARE VISIBLE.

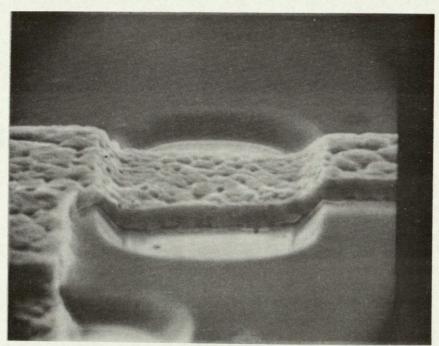
FIGURE 12 - SEM PHOTOMICROGRAPH, SUBSEQUENT TO DEPOSITED OXIDE REMOVAL, OF SAME AREA SHOWN IN FIGURE 11. PHOTOMICROGRAPH SHOWS GOOD METALLIZATION COVERAGE AT EDGE OF TAPERED OXIDE STEP.

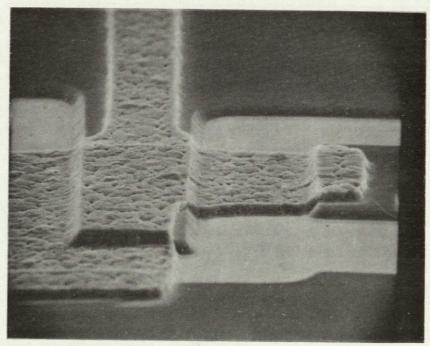
FIGURE 14 - SEM PHOTOMICROGRAPH, SUBSEQUENT TO DEPOSITED OXIDE REMOVAL, OF THE SAME AREA SHOWN IN FIGURE 13. THE PHOTOMICROGRAPH ILLUSTRATES GOOD METAL COVERAGE AT THE TAPERED OXIDE STEPS.

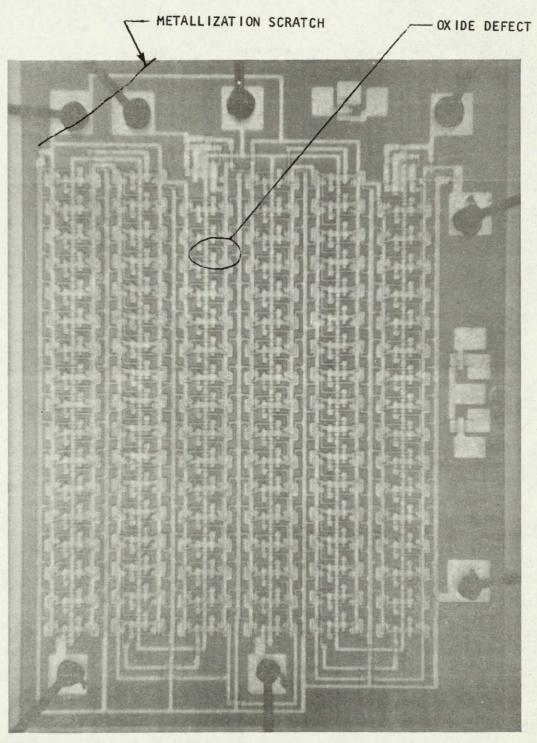
All of the assembled Phase I MOS test vehicles have been subjected to pre-seal visual inspection and have been returned to our production area for encapsulation. Every abnormality observed has been recorded on an individual printed copy of a photomicrograph of the test element, together with the identification the device will retain through all subsequent testing and evaluation. The record of the visual abnormalities will be utilized to correlate any failure incurred with the microscopic observations. Figure 15 is a typical example of the method utilized to record the microscopic preseal visual observations.

FIGURE 15 - ILLUSTRATION OF METHOD BEING UTILIZED TO RECORD OBSERVED PRE-SEAL VISUAL DEFECTS.
